Tree Inspection Report

39 Brook Street, London W1

February 2017

Client: Grosvenor London
Location: 39 Brook Street, London, W1K 4JE
Date of inspection: 16 February 2017
Inspector: J. Harraway F Arbor A, MICFor, Dip Arb (RFS)
Our reference: TIR/0217/3

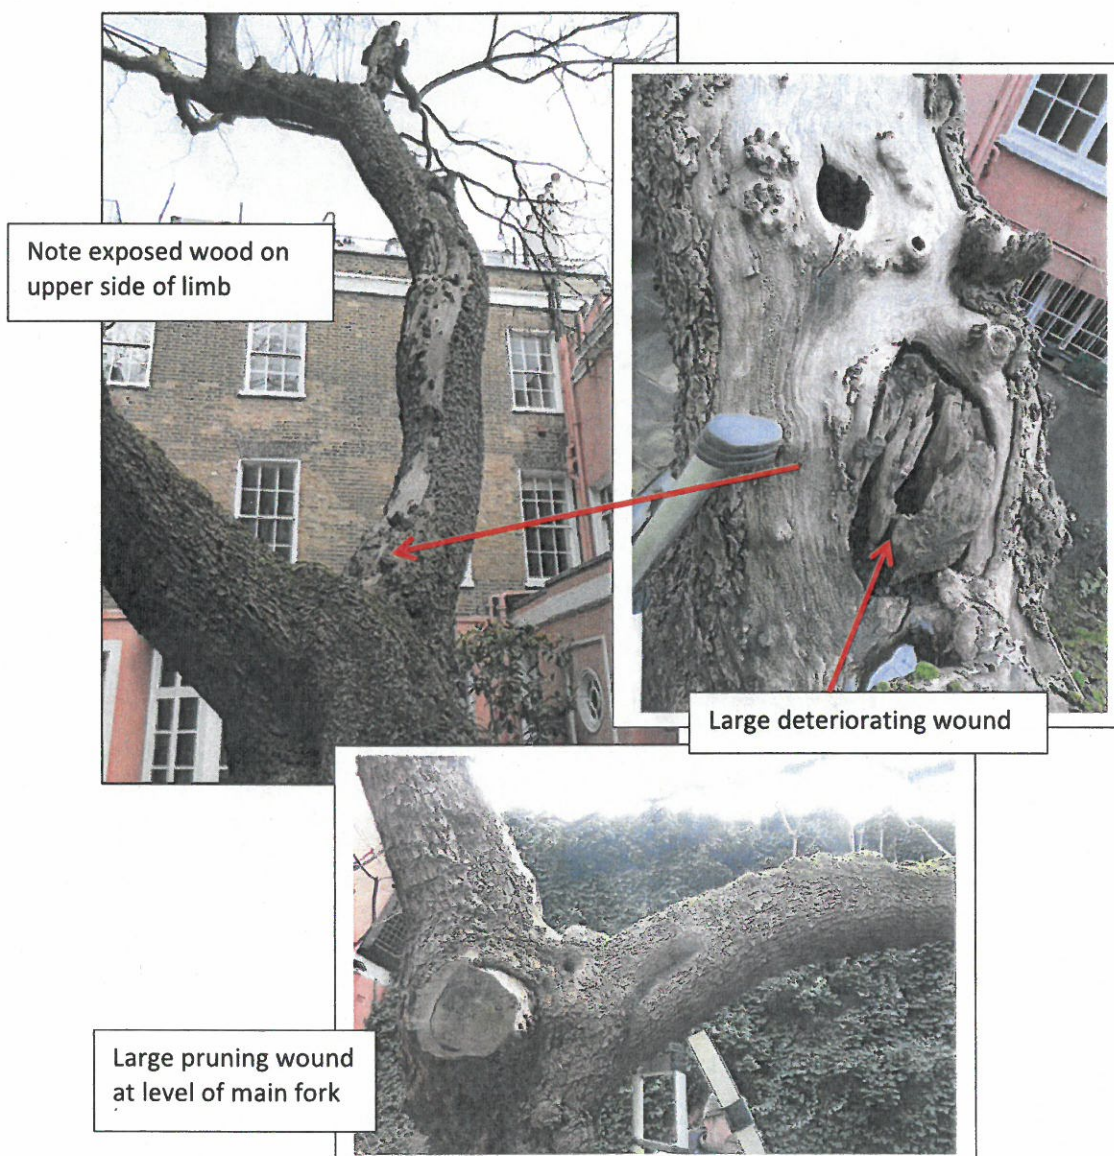
A large limb has previously been removed from the west side of the stem, just below the level of the main fork, leaving a short dead stub. The ascending limb on the north side exhibits extensive bark loss on its upper side from the fork and extending some four metres up the limb and also affecting the first lateral limb to the west. Cavities are evident at the base of the limb at the site of limbs now removed. See photos below:

A further lower limb on the west side has also suffered extensive bark loss and is virtually dead. The remaining crown is somewhat sparse, due in part to previous pruning work, and its vigour appeared low (accurate assessment of vitality was limited by the season of inspection).

- Consider making application for the tree's removal and replacement whilst the property is uninhabited
- If the tree is retained beyond the short term, the crown should be reduced in height by 2-3 metres, depending on available options for pruning to suitable secondary growth in each instance; dysfunctional limb in the lower crown should also be removed, and:
- The tree's level of vigour, post-reduction, should be monitored regularly by those on site and arboricultural assistance sought if deterioration is noted, and:
- A further assessment of the tree's physiological and structural condition should be carried out in 2-3 years

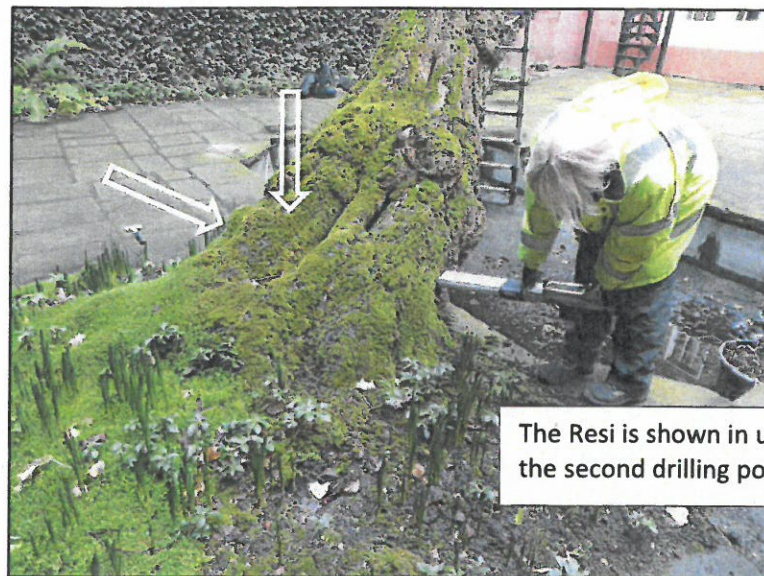
The base of the stem was investigated using the Resi micro-drill on its north and south sides and from the top of the stem, through the part affected by previous delamination (see below):

The Resi is shown in use in the second drilling position

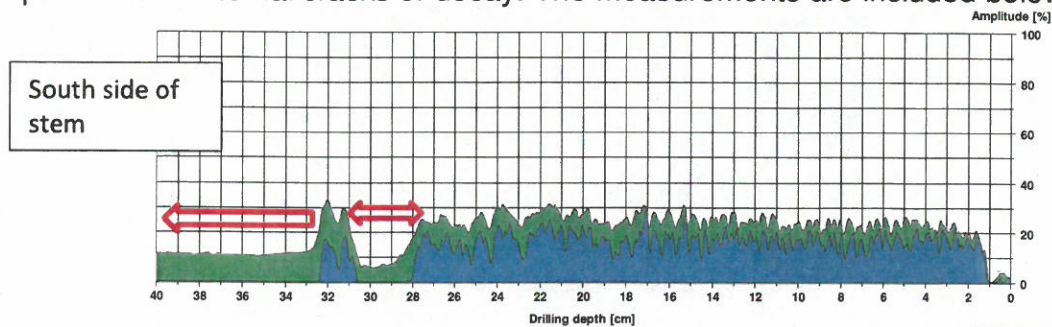
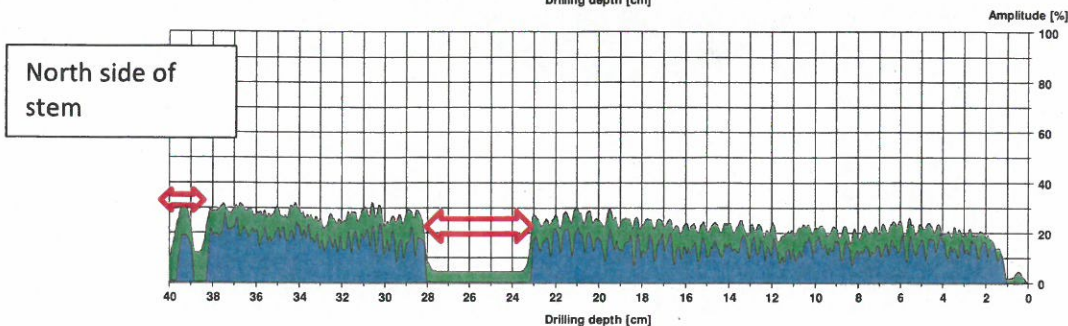
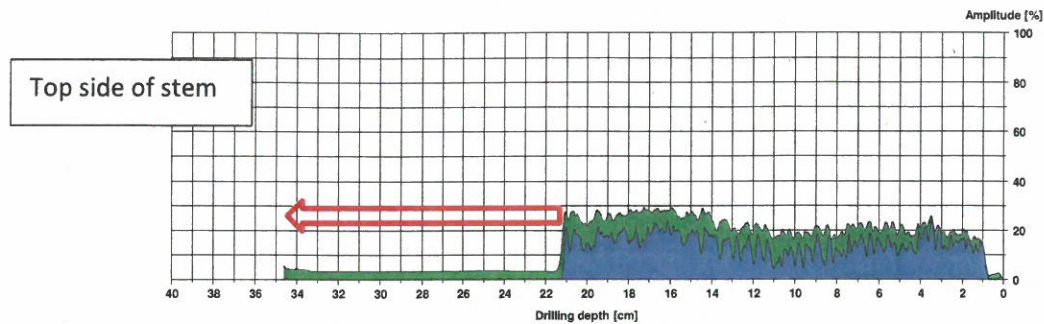
Drops in drilling resistance were recorded at each drilling location, suggesting the presence of internal cracks or decay. The measurements are included below:

The needle was auto-retracted on the last measurement at a depth of 34cm due to deviation caused by a lack of lateral support within a void.

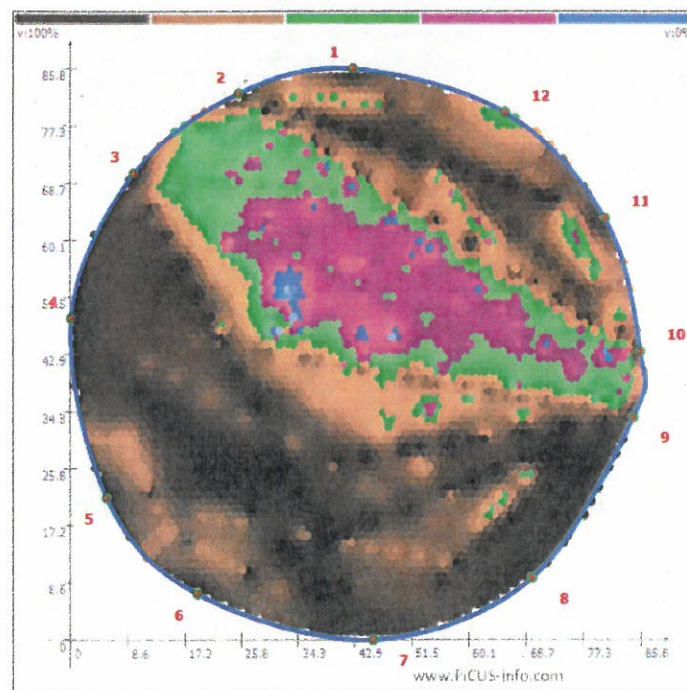
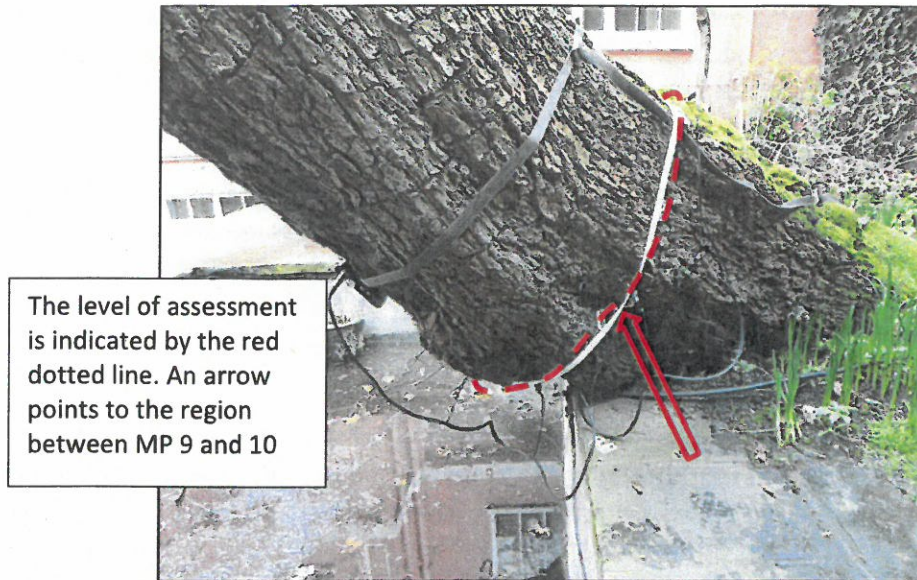
The main stem was also investigated with the Picus; however due to the requirement to place measuring points around the complete stem, this was carried out at the level at which the recumbent stem clears the side of the pool. A total of twelve measuring points (MP) were used, with MP 1 placed on the upper side of the stem. The stem shape was assumed to be circular as exact measurement of its geometry was hindered due to its proximity to the proximity of the pond; however the exact location of each measuring point around the stem circumference is recorded.

A distinct zone of reduced sonic velocity is indicated across the upper side of the stem from MP 9-10 to MP 2-3 (coloured maroon/green). The form and location of the area of lowered sonic velocity suggests the presence of a significant internal crack, possibly accompanied by some decaying wood. The result appears to corroborate the results with the Resi micro-drill.
