Arboricultural Appraisal Report

Subsidence Damage Investigation at:

**55 Hamilton Terrace
London
NW8 9RG**

**CCTV REPORT FOR: 55 HAMILTON TERRACE
LONDON
NW8 9RG**

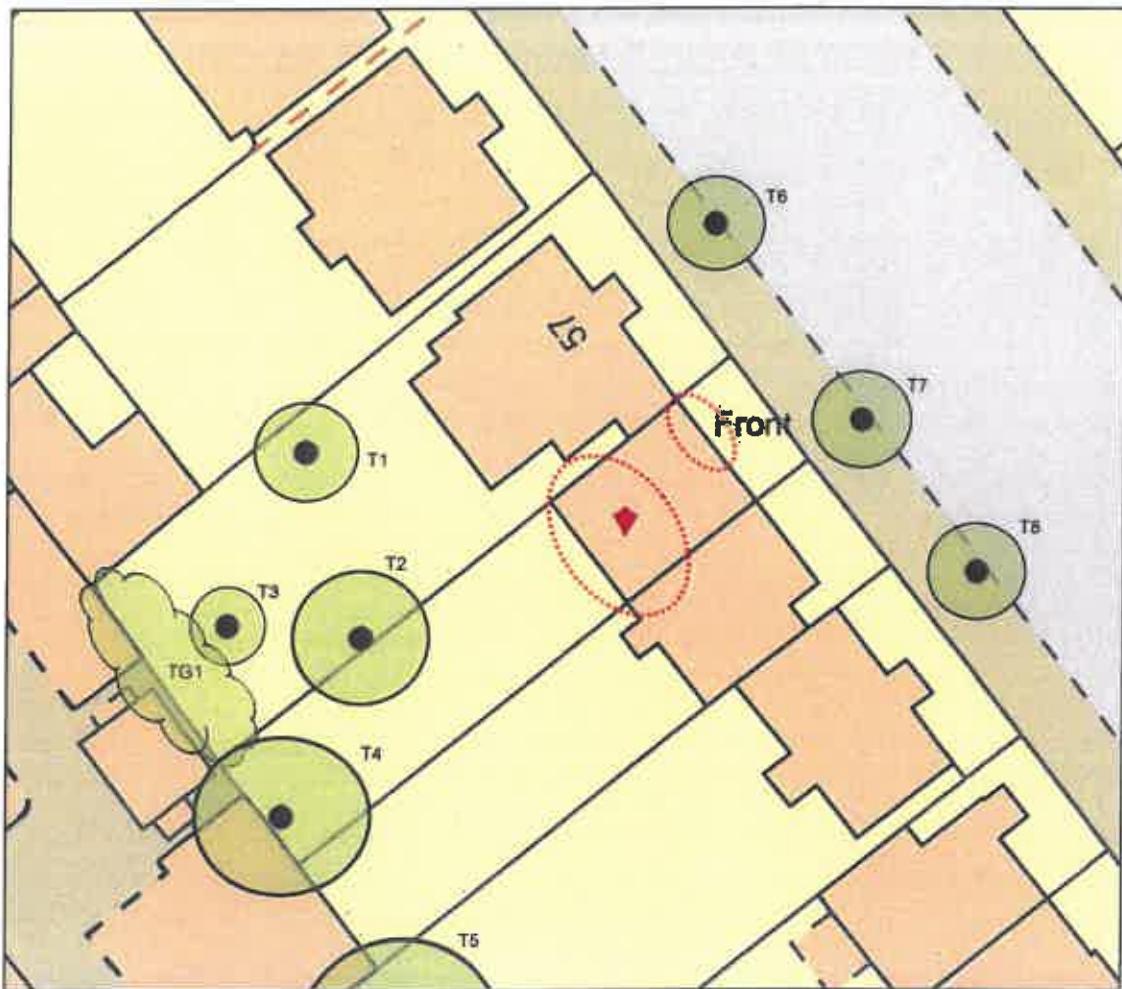
SITE PLAN

Approximate areas of damage

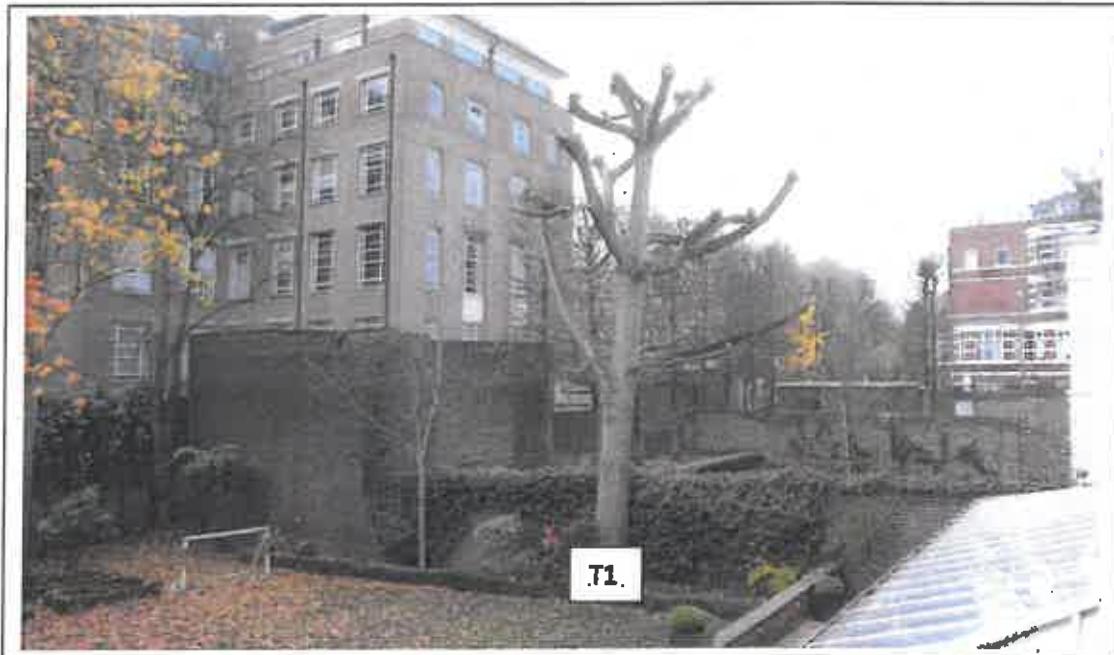
We have identified numerous trees in and around the property, most notable of which are the third party T1 Poplar and T2 Norway Maple to the rear and the Local Authority T6, T7 and T8 London Planes to the front, all of which have the potential to be contributory cause of the damage. All except T2 Norway Maple have however been recently pollarded.

View of T1 Poplar

Tree No.	Species	Ht (m)	Dia (mm)	Crown Spread (m)	Dist. to building (m)	Age Classification	Ownership
T1	Poplar	10.0	600 *	9.5 *	16.0	Younger than Property	Third Party: 57 Hamilton Terrace, NW8 9RG
Management history		Subject to past management – very recently pollarded. No visible regrowth					
Recommendation		Prune on a triennial cycle (re-pollarding)					
T3	Poplar (Lombardy)	21.0 *	400 *	4.5*	21.6	Younger than Property	Third Party: 57 Hamilton Terrace, NW8 9RG
Management history		No past management noted.					
Recommendation		Do not allow to exceed current dimensions.					
T4	Tree of Heaven	17.5	740	16.0	24.1	Younger than Property	Policy Holder
Management history		No past management noted					
Recommendation		Do not allow to exceed current dimensions					
T5	Plane (London)	19.5*	900 *	12.0*	35.0*	Younger than Property	Third Party: 51 Hamilton Terrace, NW8 9RG
Management history		No past management noted

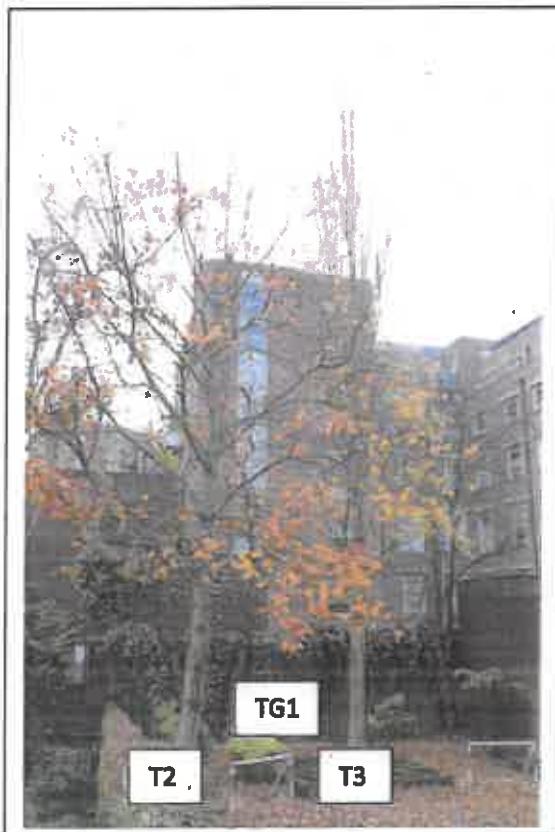
View of T2 Norway Maple, T3 Lombardy Poplar and TG1 Lime group to rear

In view of the above, if an arboricultural solution is to be implemented to mitigate vegetation influence we recommend that in the first instance T2 Norway Maple is removed. Given the recent pollarding of T1 Poplar and T6, T7 and T8 London Planes, further works are potentially not necessary. If movement persists however following the removal of T2, or where other species are directly implicated as a current factor in the damage, further works may be required.

Tree No.	Species	Ht (m)	Dia (mm)	Crown Spread (m)	Dist. to building (m)	Age Classification	Ownership
T2	Maple (Norway)	13.5	450 *	11.0	14.1	Younger than Property	Third Party: 57 Hamilton Terrace, NW8 9RG
Management history		No past management noted.					
Recommendation		Remove (fell) to near ground level and treat stump to inhibit regrowth

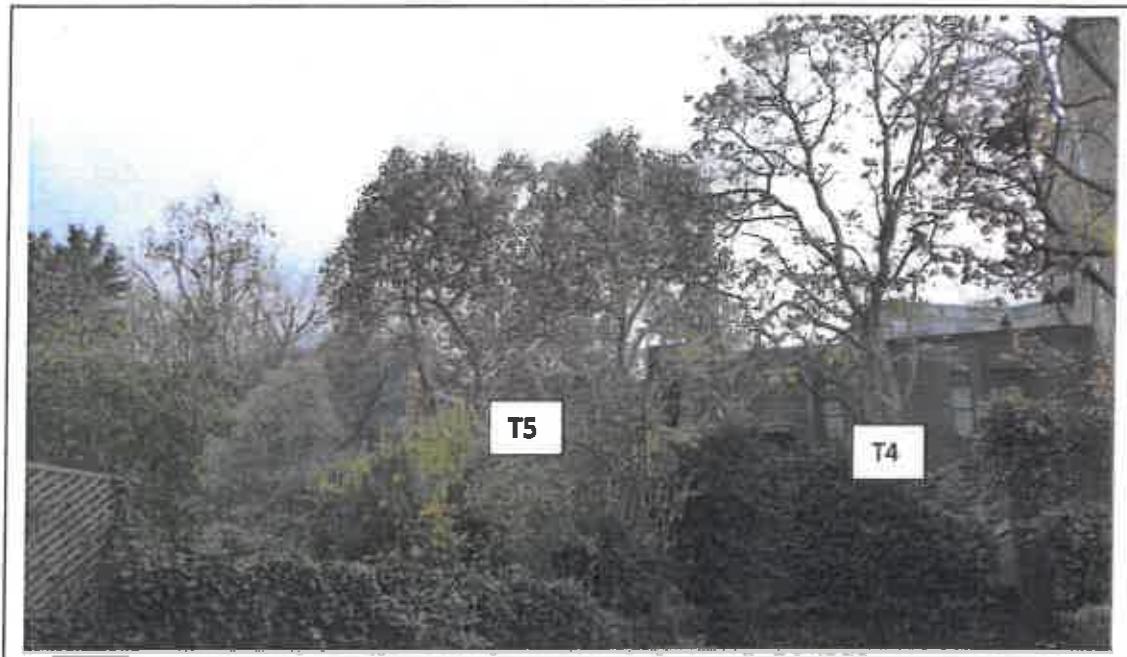
View of T4 Tree of Heaven and T5 London Plane [small PH shrub based vegetation to foreground not recorded – not considered relevant to the damage]

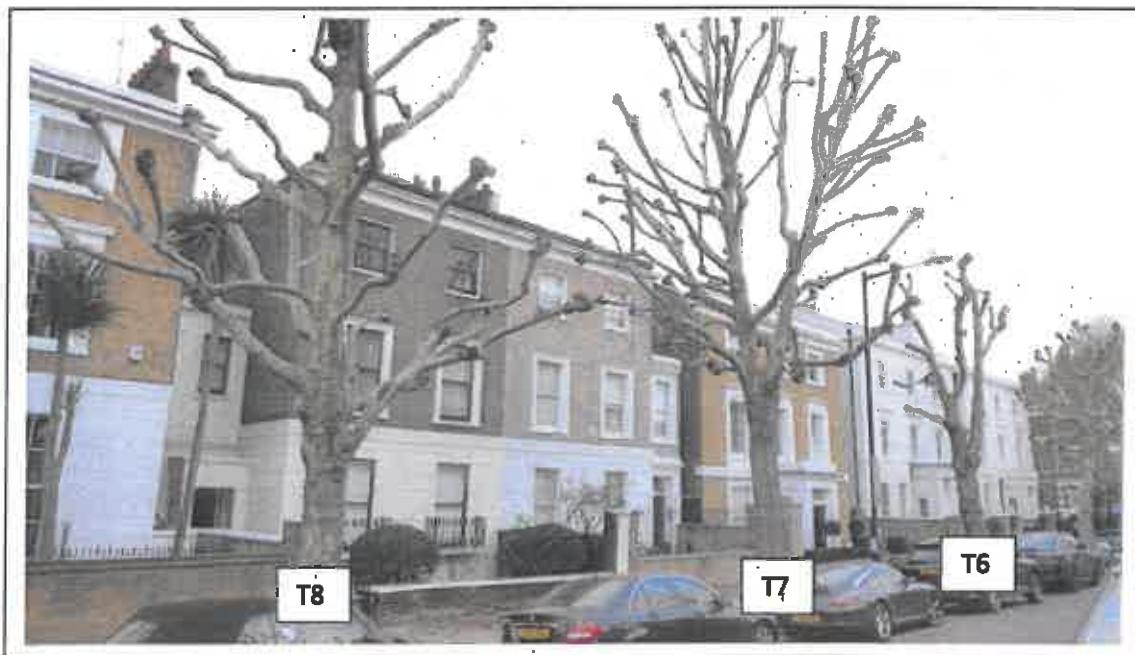
View of T6, T7 and T8 London Plane

Recommendation		Do not allow to exceed current dimensions					
T6	Plane (London)	10.5	720	5.0	9.4	Younger than Property	Local Authority
Management history		Subject to past management – very recently pollarded. No visible regrowth					
Recommendation		Pollard annually

Tree No.	Species	Ht (m)	Dia (mm)	Crown Spread (m)	Dist. to building (m)	Age Classification	Ownership
T7	Plane (London)	11.5	670	7.5	8.2	Younger than Property	Local Authority
Management history		Subject to past management – very recently pollarded. No visible regrowth					
Recommendation		Pollard annually					
T8	Plane (London)	10.0	530	5.5	13.0	Younger than Property	Local Authority
Management history		Subject to past management – very recently pollarded. No visible regrowth					
Recommendation		Pollard annually					
TG1	Lime group	14.0	320 Ms *	5.0	24.7	Younger than Property	Third Party: 57 Hamilton Terrace, NW8 9RG
Management history		No past management noted					
Recommendation		Do not allow to exceed current dimensions

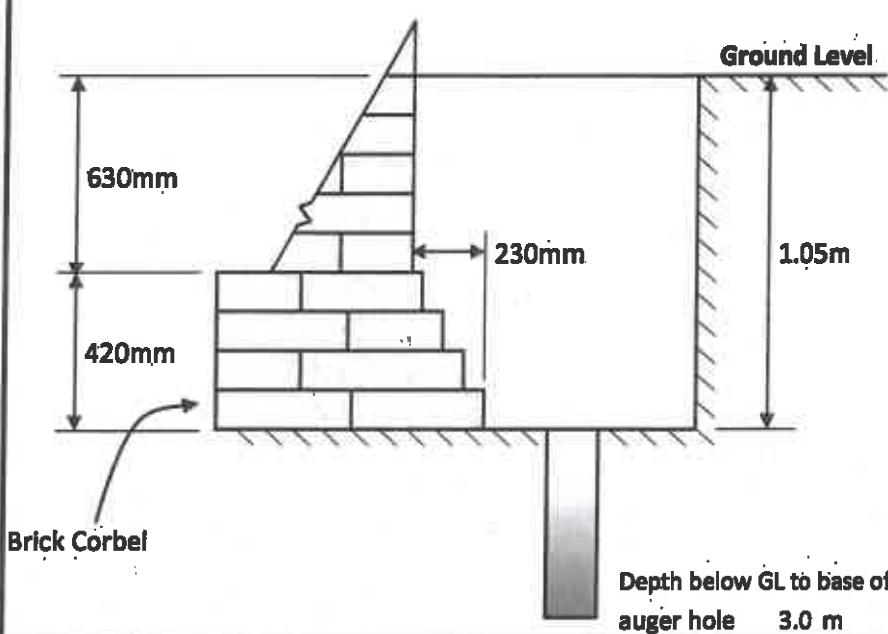
T/H No. 1

None observed on site

Hit at 1.05m

Depth (m)	Soil Descriptions <i>(Field crew description only)</i>	Test		Depth (m)	
		Type	From	To	
G.L.					
1.05	Firm brown CLAY				
2.00	Stiff brown CLAY				
3.00	End of Borehole

T/H1 relocated due to presence of gully and pipework in proposed location.

Some water noted below footing.

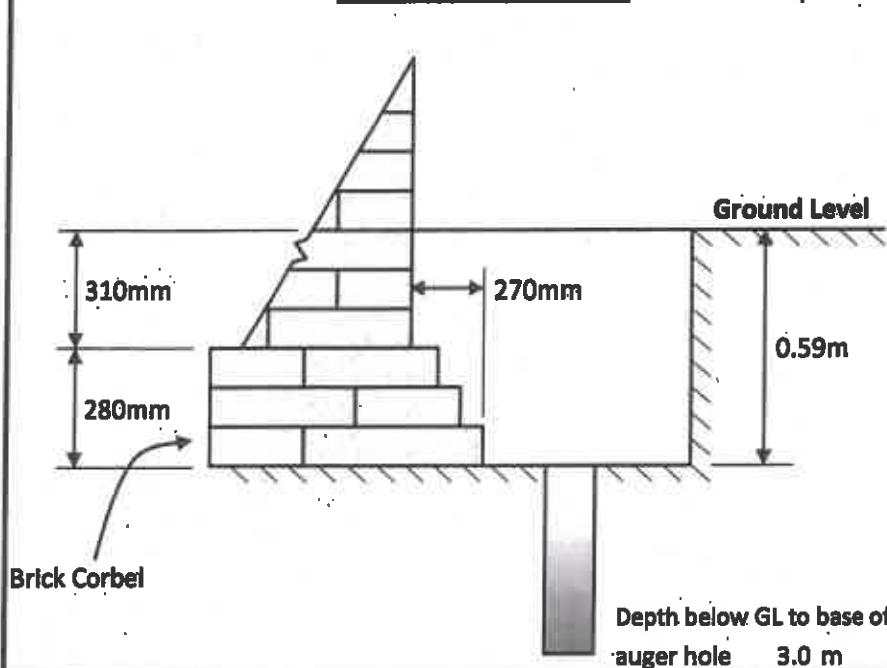
T/H No. **2**

Down to 1.5m

up to 2mm diameter

None observed on site

Depth (m)	Soil Descriptions (Field crew description only)	Test Type		Depth (m)	
		From	To		
G.L.					
0.59	Firm brown CLAY				
1.00	Stiff brown CLAY				
3.00	End of Borehole

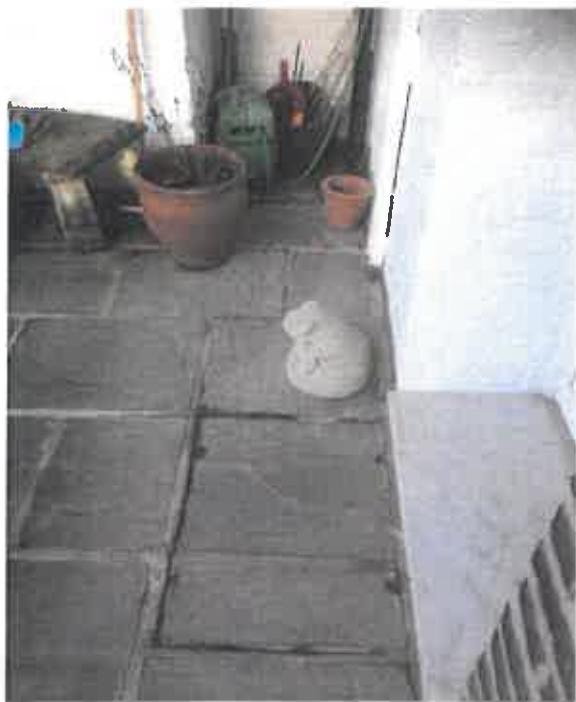
I/C1 Upstream to FWG1

Metres	Faults / Defects	Remarks
0.60		Inlet at 3 o'clock to boiler room
1.73	No Visible Defects	At FWG1
		End of survey

No visible pipework defects.

No recommendations are required.

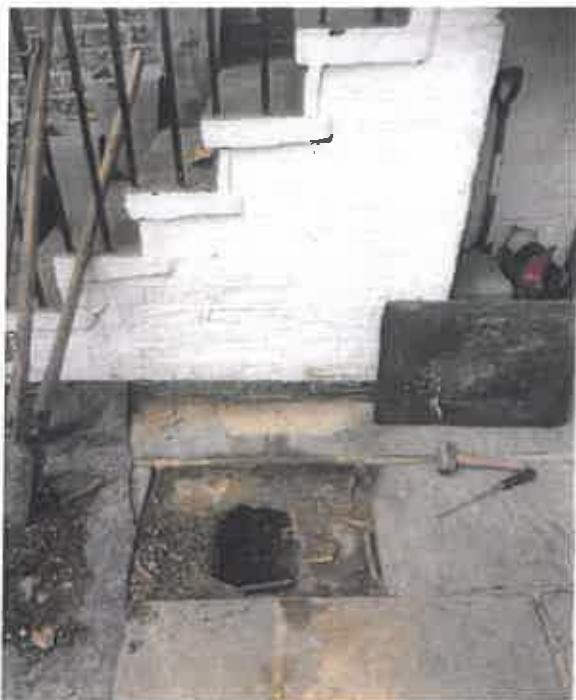
B/H1

Location: Rear Garden		B/H No. 1	
Ground Surface: Dry	Weather: Dry	Date: 22-Nov-18	
		Roots Depth & Diameter: Down to 1.5m up to 2mm diameter	
		Water Depth Hit & Rise: None observed on site	
<u>Borehole Only</u>			
Depth (m)	Soil Descriptions (Field crew description only)	Test	
		Type	Depth (m) From To
G.L.			
1.05	Firm brown CLAY		
2.00	Stiff brown CLAY		
3.00	End of Borehole		
Photograph

5 no. Examined root: the family SALICACEAE (Salix (Willows) and Populus (Poplars)).
1 no. A piece of BARK only, insufficient material for identification.

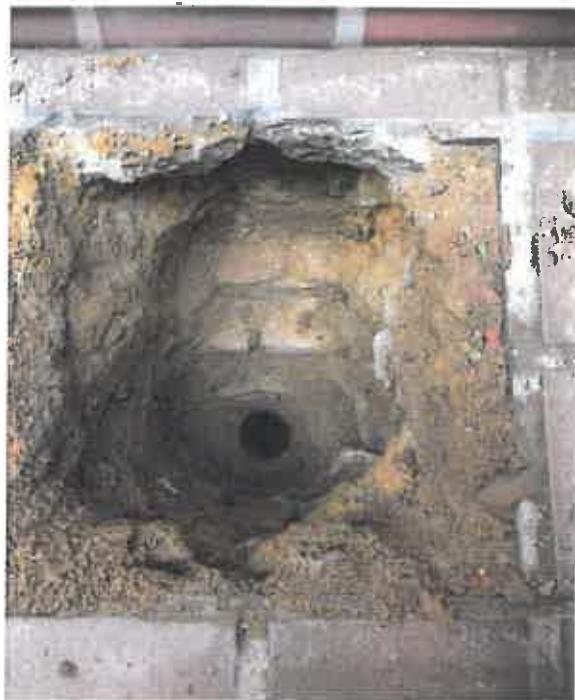
T/H2

5 no. Examined root: PLATANUS (Plane).
