Shirland Road/Elgin Avenue LSS

WA1502H2T Brief 16xxx  
Accident Remedial Study 2014-15

City of Westminster

Report: Accident Remedial Study 2014-15

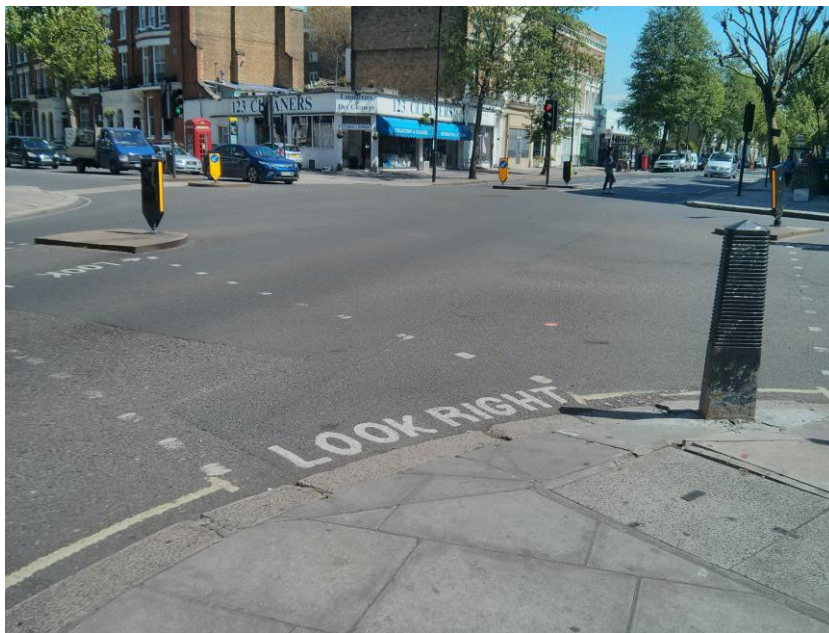
- 1.4.1 The junction of Shirland Avenue and Elgin Avenue is signalised but does not have a pedestrian phase. It is part of a SCOOT link which coordinates with nearby junctions to help vehicle movement through the network. The IBUS system is also used at this junction which is a method of bus priority that allows buses to be progressed through traffic signals by prioritising their passage to improve speed and reliability for passengers.
- 1.4.2 A plan of the signal layout and timings are located in Appendix D. The junction has two stages, when Elgin Avenue (both arms) are in red phase, Shirland Road has the go ahead and all movements are permitted, and when Shirland Road is in red phase, vehicles from Elgin Avenue are permitted to make all movements.

*Photograph 1 – Overall look of the junction from North-east arm of Elgin Avenue*

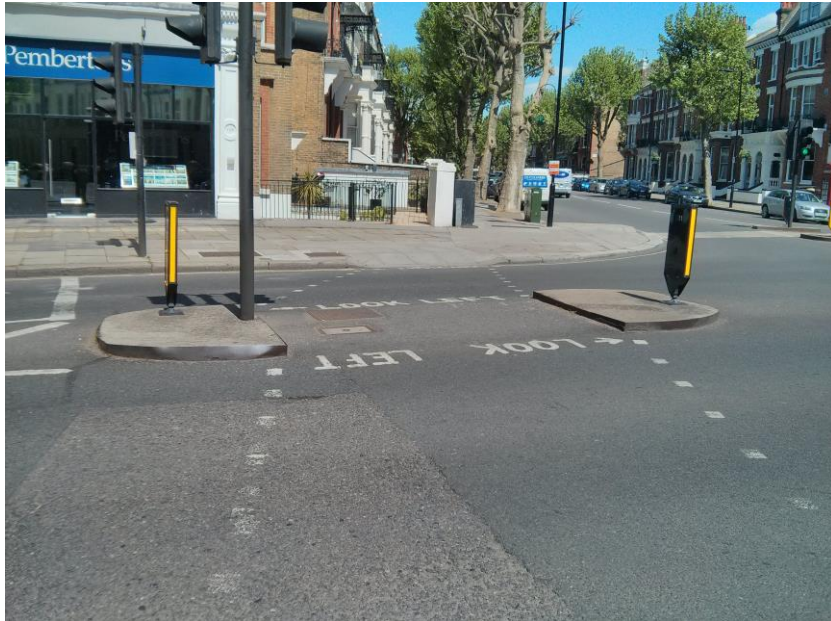
- 1.4.3 All arms of the junction have one approach lane and one exit lane, on Elgin Avenue on the north eastern arm the road has been built out on both sides. Each arm of the junction has a refuge which is approximately 2m wide and 1.2m in length. Keep left self-righting bollards are located on each island; each refuge also has a primary signal plus the secondary signal head for the opposite arm of the junction.

*Photograph 2 – Example of islands - located on north-west arm of Shirland Road*

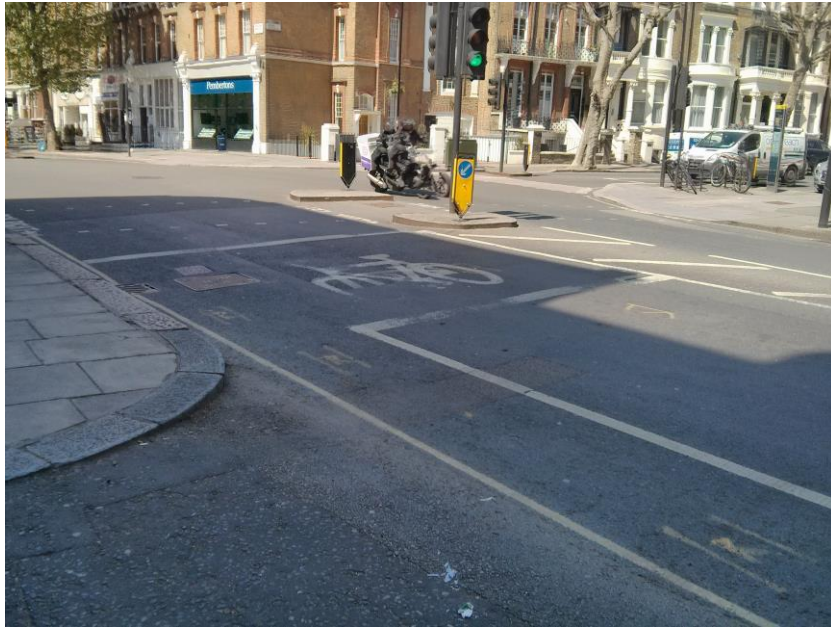
- 1.4.6 Some cycle facilities have been provided at this junction these are located on the Shirland Road arms of the junction. The cycle reservoirs for both arms are approximately 4m wide with a 15m long cycle lane on the north-western arm that is 1.3m wide and a 19m long cycle lane on the south-eastern arm that is 1.2m wide. Elgin Avenue does not have a cycle lane or reservoir. Though there is cycle parking facilities located on north-eastern arm of Elgin Avenue on the south east side.

*Photograph 4 – Cycle reservoir and cycle lane on south-east Shirland Road*

- 1.6.5 Though only one collision involved a cyclist, it is proposed to add the cycle reservoirs (5m) on both arms of Elgin Avenue, but only a lead in cycle lane of the south-western arm of Elin Avenue, due to the increased popularity of cycling in the borough and across London.

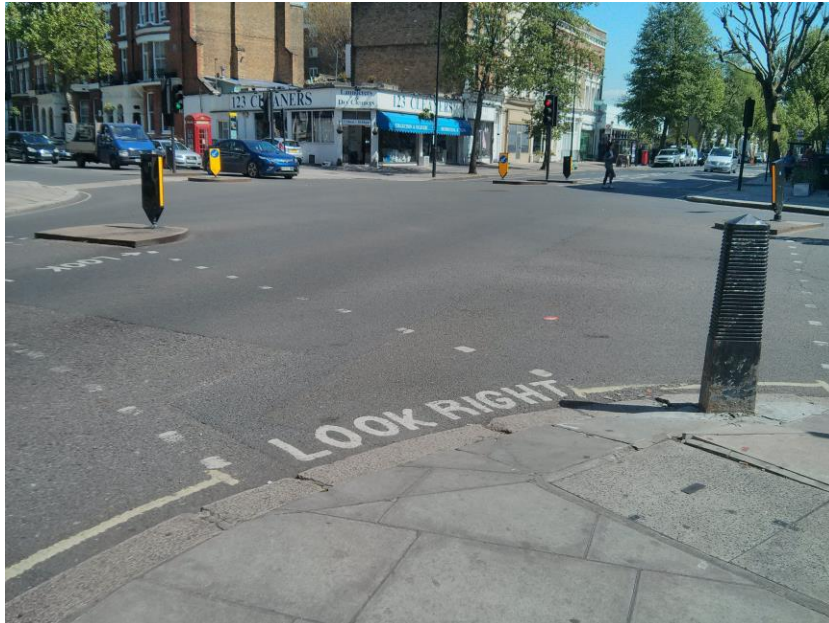
- 1.4.7 As mentioned earlier in the report, Shirland Road forms part of the London bus network. Bus cages are located near the junction on the south-eastern arm of Shirland Road, both bus cages are 37m long and are highly utilised.
- 1.4.8 The junction is surrounded by single yellow lines, as there are no signs notating the times; the waiting restriction is that of the controlled parking zone. For this area the controlled parking zone is C1. The waiting restrictions for the zone are Monday – Friday 8:30am – 6:30pm. No loading restrictions were noted at this junction.

*Photograph 4 – Single yellow lines at the junction on all arms – taken from North-west arm of Shirland Road*

- 1.6.7 As standard practice in Westminster City Council is to protect a junction with double yellow line 'at any time' waiting restrictions It is proposed to install double yellow lines around the junction up to the nearest parking bay or with a 10m minimum.. It is proposed to upgrade to 'No loading at any time' restrictions around the mouth of the junction, approximately 10m to ensure that no vehicles obscure visibility between road users or block access to the crossing. This would further enforce the Highway Code which states that "do not stop or park opposite or within 10 metres (32 feet) of a junction, except in an authorised parking space".

- 1.6.8 With trial authorisation of 'No loading at any time' double kerb blips without the need for signs to diag. 618 are proposed. The proposal will not add street clutter around the junction, which is line with WCC's policy to reduce street clutter.
