REPORT RECOMMENDING THE MAKING OF A TREE PRESERVATION ORDER BY THE EXECUTIVE DIRECTOR GROWTH PLANNING AND HOUSING UNDER DELEGATED POWERS.

DR. FRANK HOPE

- inspect the golden-leaved False Acacia tree (*Robinia pseudoacacia* 'Frisia') located on the elevated section of the small, rear garden, of number 21 Chepstow Place, London;
- discuss the implications of any legal protection of the tree;
- assess the overall condition of the tree, and assess its safe life expectancy;
- quantify the quality of the tree in accordance with the category rating definitions in British Standard 5837 (April 2012 edition);
- make comment on the damage that the False Acacia is causing to the rear boundary wall of the property;
- identify remedial measures to ensure the integrity and safety of the tree and

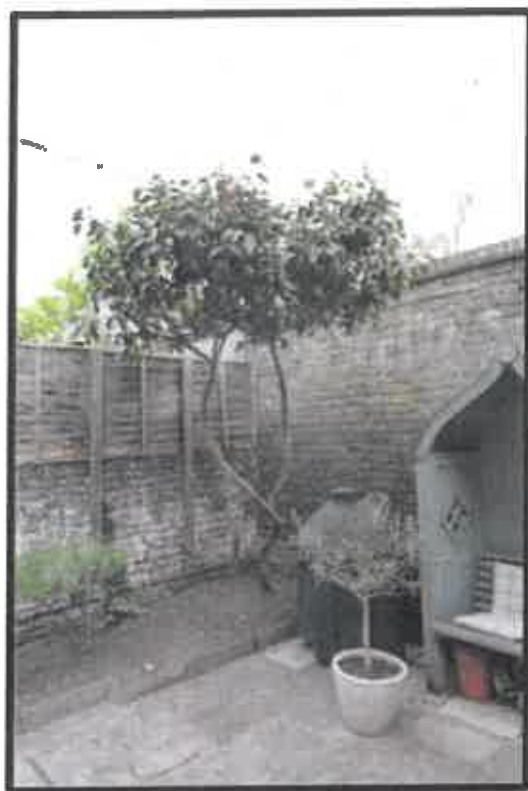
Picture showing the small rectangular bed on the upper section of garden, containing a poor quality 2.5 metre tall Camellia shrub.

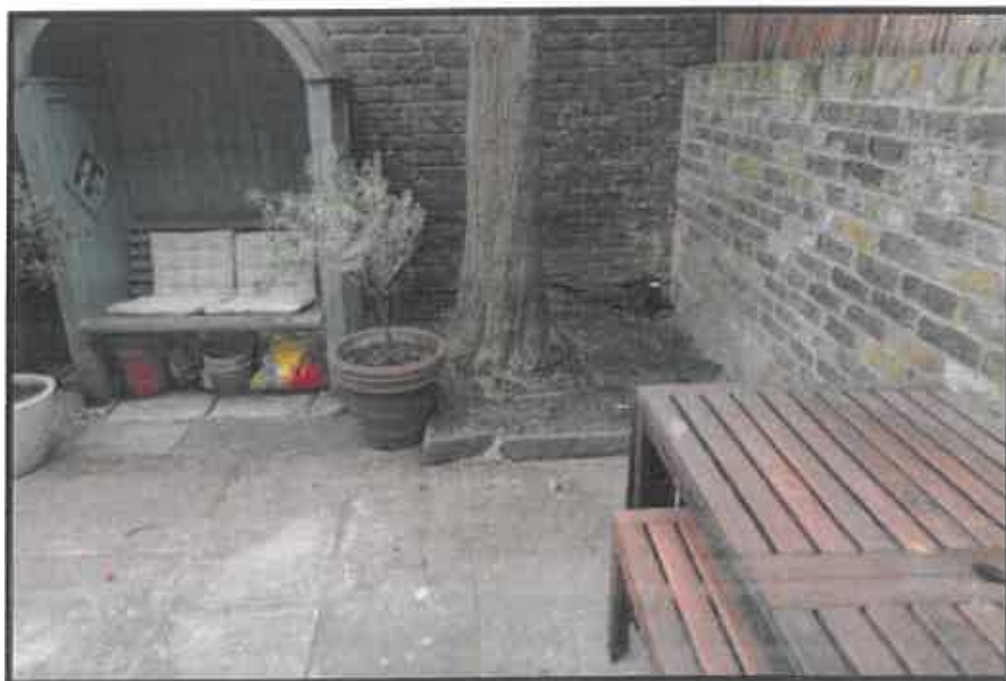
Picture showing the False Acacia in the square bed on the upper level of the rear garden.

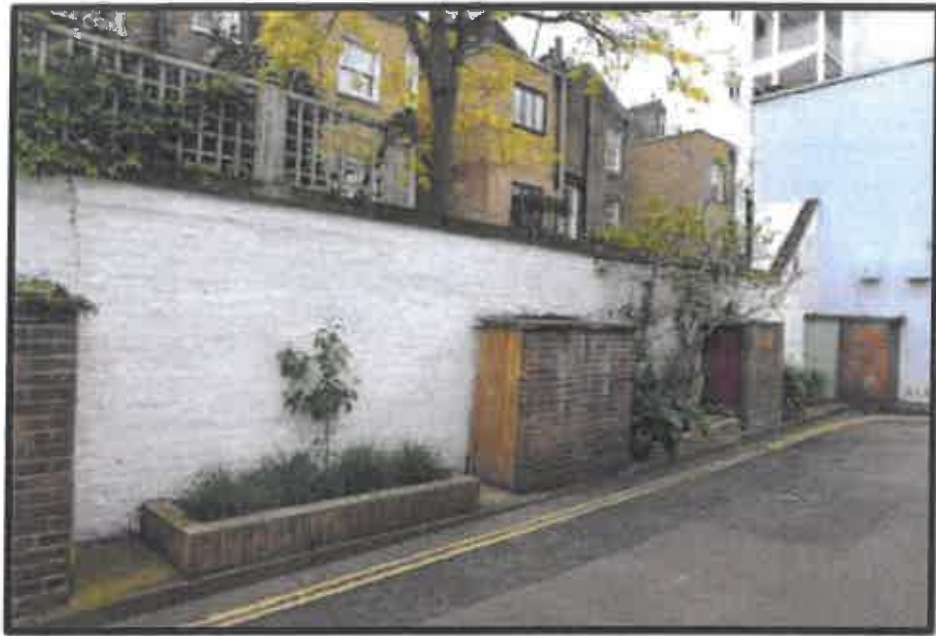
Picture showing the storage shed along Rede Place, against the eastern side of the boundary wall.

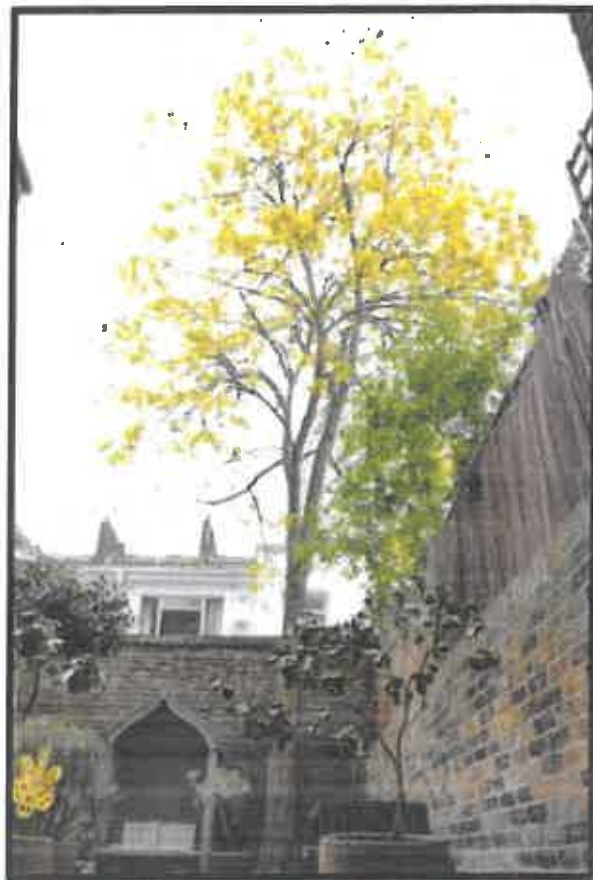
Picture showing the False Acacia in the rear corner of the property.

- 4.1 As mentioned in item 3.4 above, the Golden-leaved False Acacia is located in a small, slightly raised, rectangular bed in the rear, south-eastern corner of the elevated section of the garden (See the picture on page 6 above).

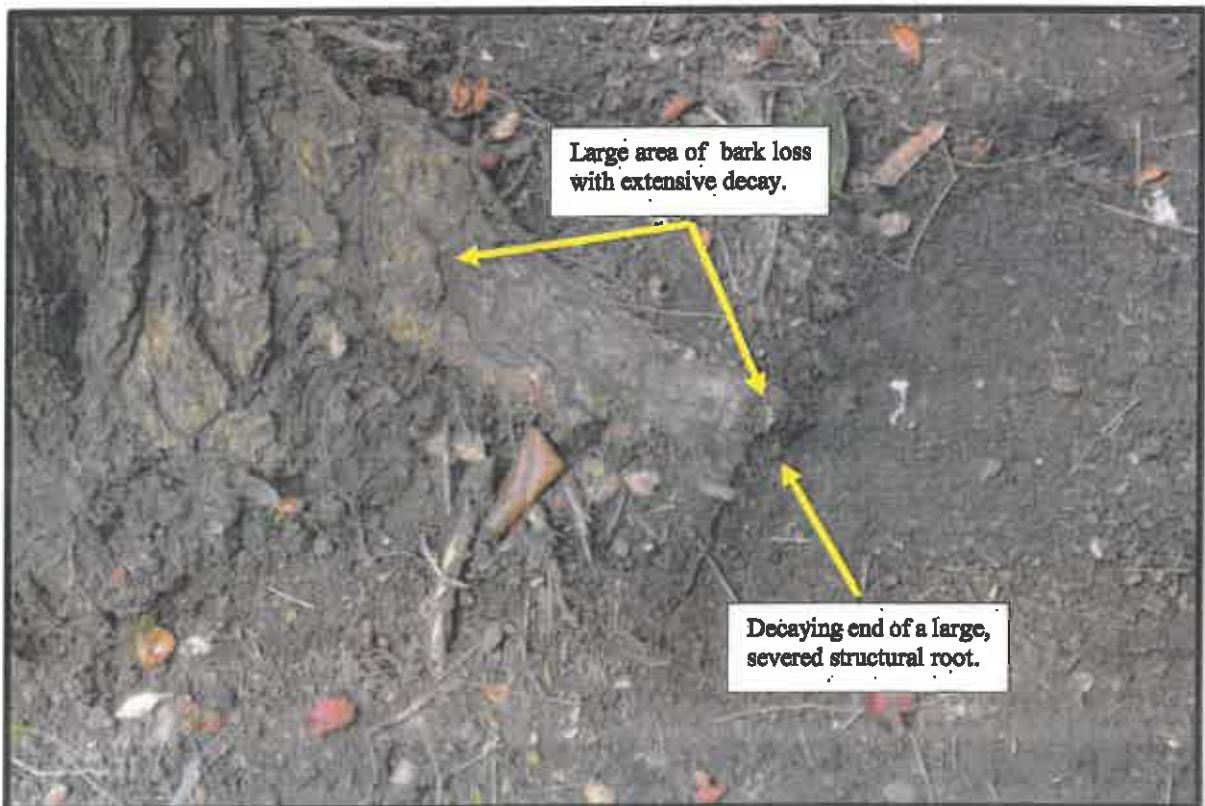
Picture showing a large diameter decaying root which has been severed in the past. The loss of bark and decay extends back to the basal trunk.

- 4.4 Physical damage has occurred to some of the roots. One large, surface, structural root, with a severed (by saw) end of approximately 90mm diameter is now exhibiting extensive signs of decay at its distal end. There is extensive bark loss and decay extending approximately 400mm back to the basal trunk, and the root is in the region of 350mm diameter adjacent to the bole of the trunk. It is the only large root on the southern side of the tree. The decay is irremediable, and will continue to worsen throughout the life of the tree. It will ultimately result in the instability of the tree. Other large girdling and decaying roots are present around the basal trunk.

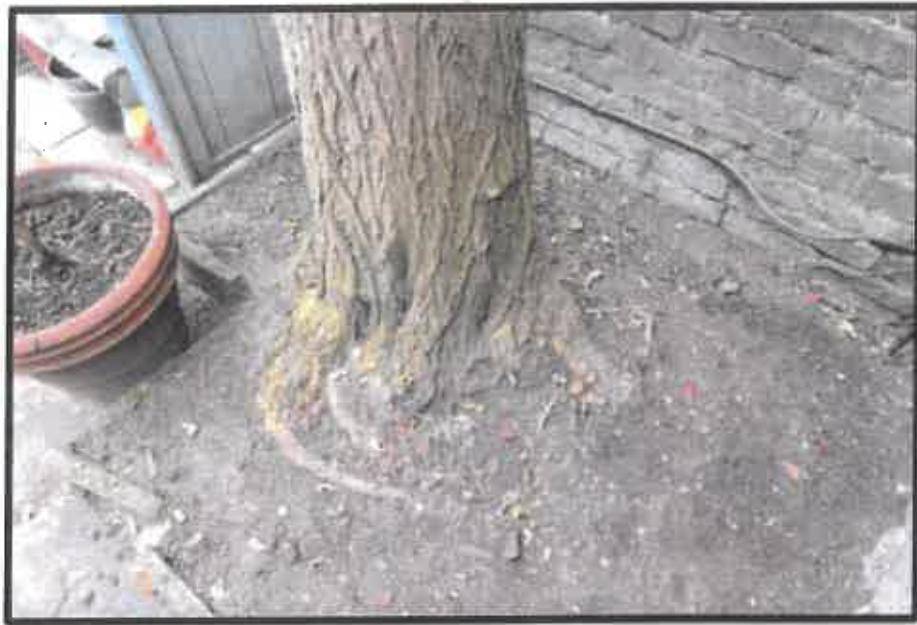
- 4.5 Dysfunctional wood is present around the basal trunk, and signs of deterioration are present within the vertical flutes of the bark at the area of the basal trunk (See the picture on page 9 below).
- 4.6 The canopy (branches) of the tree has been reduced in the past, and is slightly sparse, with extensive small dead branches present (See the second picture on page 9 below). The extent of the dead branches indicate that the tree is under stress. It is making little annual extension growth.

Picture showing the poor condition of the basal trunk of the False Acacia.

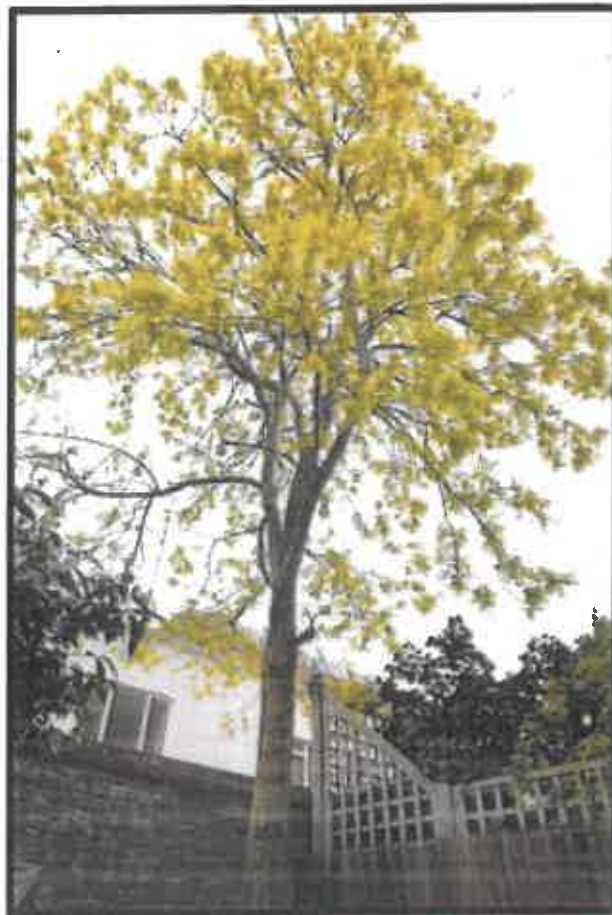
Picture showing extensive small dead branches in the tree canopy.

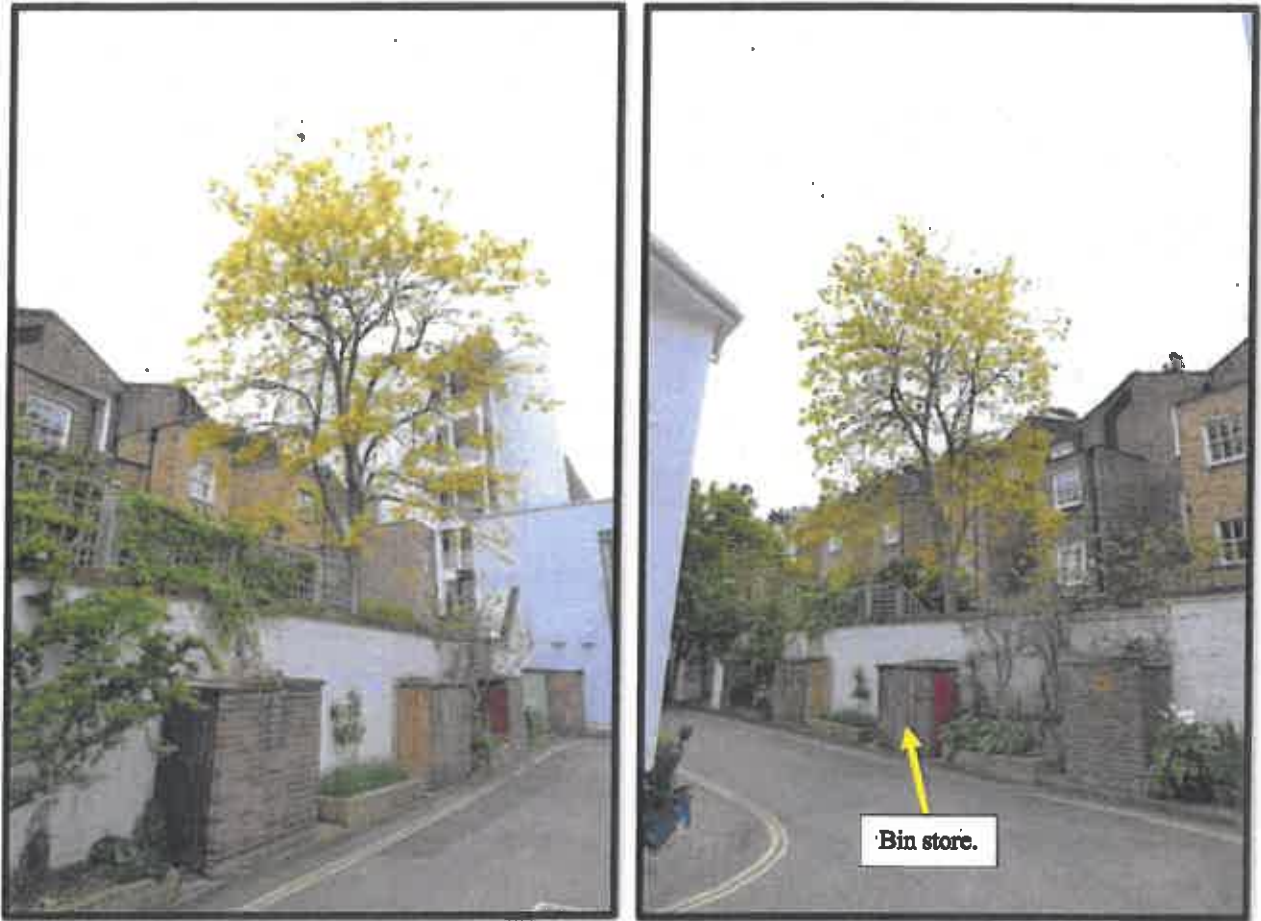
5.1 The Golden-leaved False Acacia is located adjacent to the rear wall of number 21 Chepstow Place. It can be clearly seen from both directions along Rede Place and from adjacent properties (See the pictures below).

Pictures showing the False Acacia from along Rede Place looking northwards and southwards.

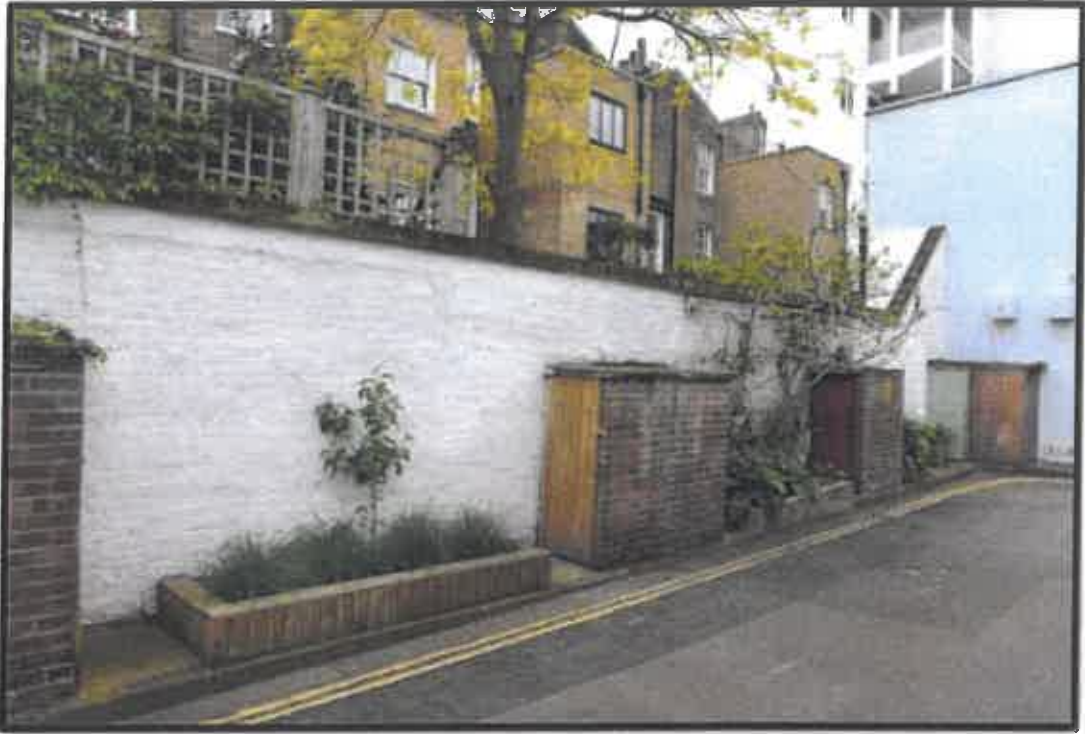
6.1 The rear boundary wall of the property borders onto Rede Place to the east. There is significant movement and cracking to the wall. There is also a brick-built bin store which has been constructed on Rede Place, butting against the wall (See the pictures above and on the following pages). This store is also exhibiting significant movement away from the wall.

Picture showing the overall unevenness of the boundary wall.

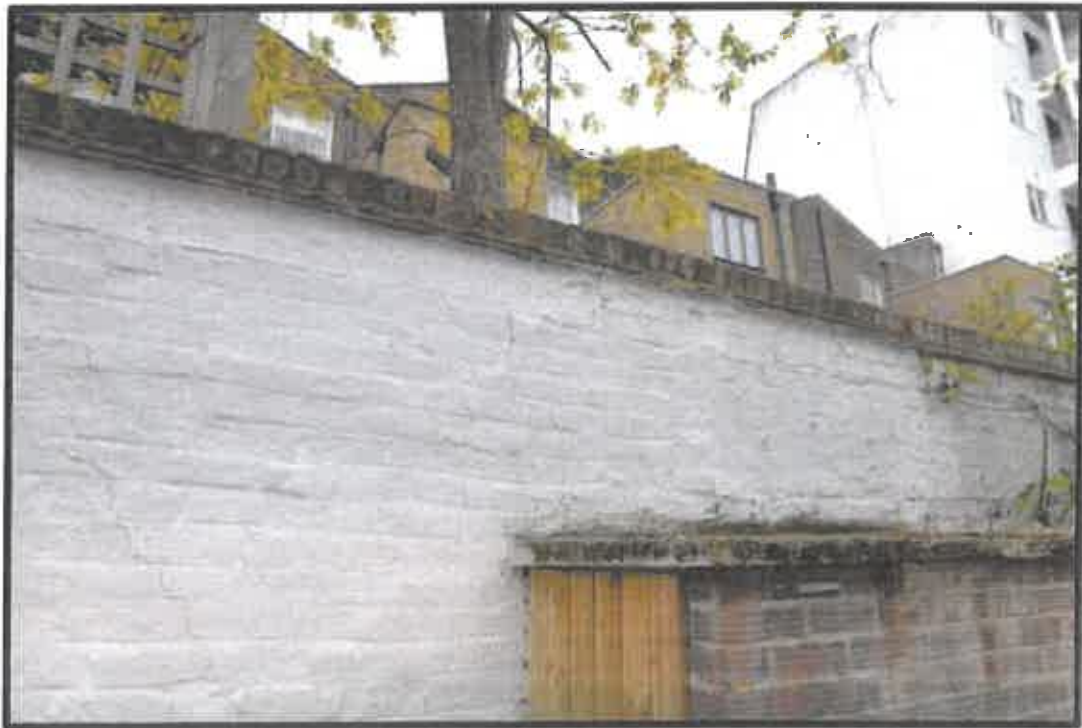
Picture showing the extensive cracking of the boundary wall.

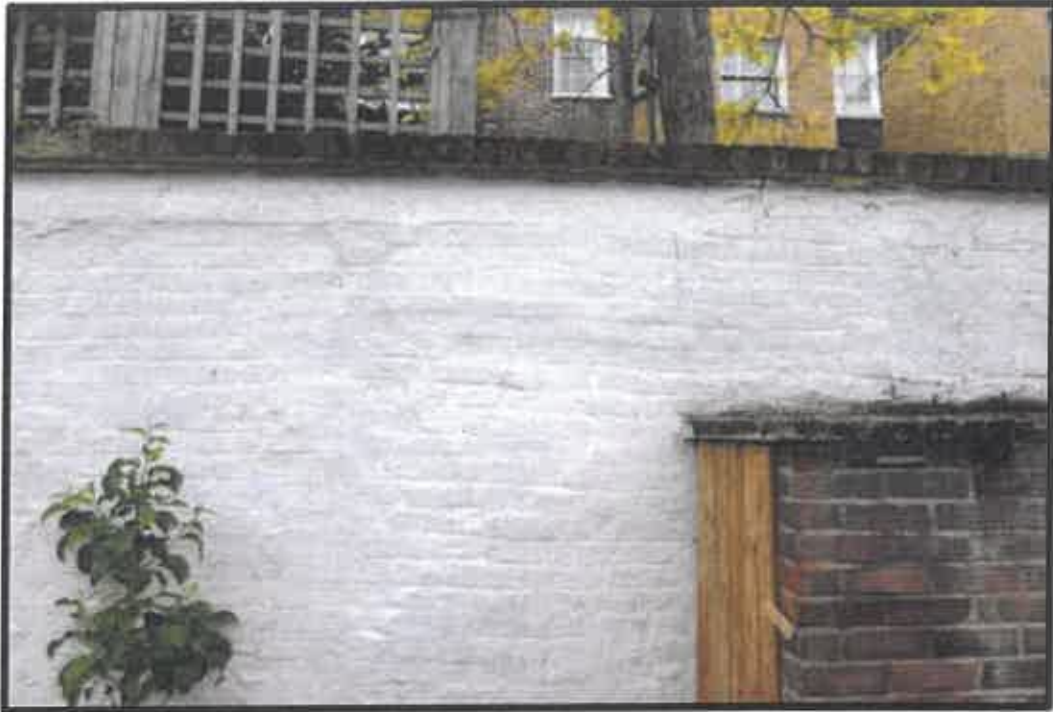
Close-up picture of the cracks in the boundary wall.

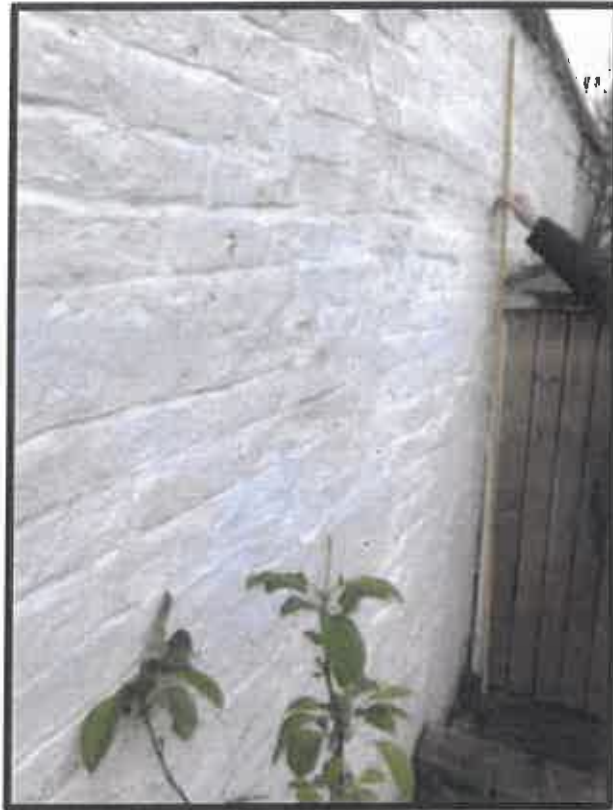
- 6.5 The rear boundary wall leans outwards towards Rede Place, by at least 100mm. Ian Drummond states that in structural engineering terms this degree of movement is significant (See below for confirmation).

Picture taken by Ian Drummond showing the lean of the wall towards Rede Place.

- 6.6 The Structural engineers have identified that for a 215mm thick solid bonded wall, an outward lean in excess of 75mm is of serious concern. This is because the self-weight of the wall, once it is leaning beyond that limit, actually contributes to further outward movement and sets up tension in the mortar courses which are inherently weak due to the soft lime mortar. Consequently, once the out-of-plumb exceeds 75mm, outward movement of the wall is likely to accelerate in the medium-term. While the Structural engineers do not consider that there is any immediate danger of collapse of the wall, they strongly advise that remedial action needs to be taken in the short-term:

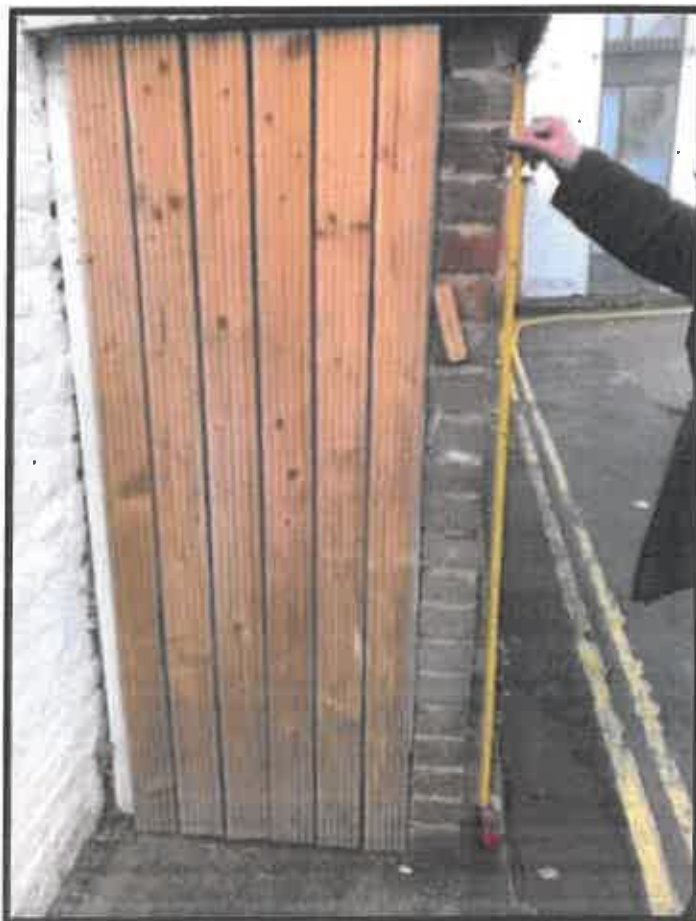
- 6.9 The Structural engineers confirm that the movement of the wall is active as identified by the presence of relatively fresh cracking in the region of the previously repaired brickwork.
- 6.10 As mentioned previously in this report, a brick-built bin store has been erected against the boundary wall on the Rede Place side. The store leans outwards towards Rede Place by 50mm, which in structural engineering terms is significant. The Structural engineers have identified that this movement has been caused by the influence of the abutting boundary wall. The outward lean of the bin store clearly indicates that the outward movement has occurred since the bin store was constructed.

Picture taken by Ian Drummond showing the lean of the bin Store.

6.11 The Structural engineers are of the opinion that while it may be possible to stabilise the wall by introducing buttresses, this is unlikely to be an acceptable solution as it would involve construction beyond the curtilage of the property. **The engineers consider that the only satisfactory means of the repair would be to take the wall down and reconstruct it plumb.** As the primary cause of the problem is the growth of the adjacent tree, it is essential that the tree is removed as part of the operation, and that the wall is rebuilt on a new foundation that extends below the level of tree root activity. They also recommend that in rebuilding the wall it should be tied into the returning party fence at each side to provide a buttressing action and add stability to the relatively high wall.

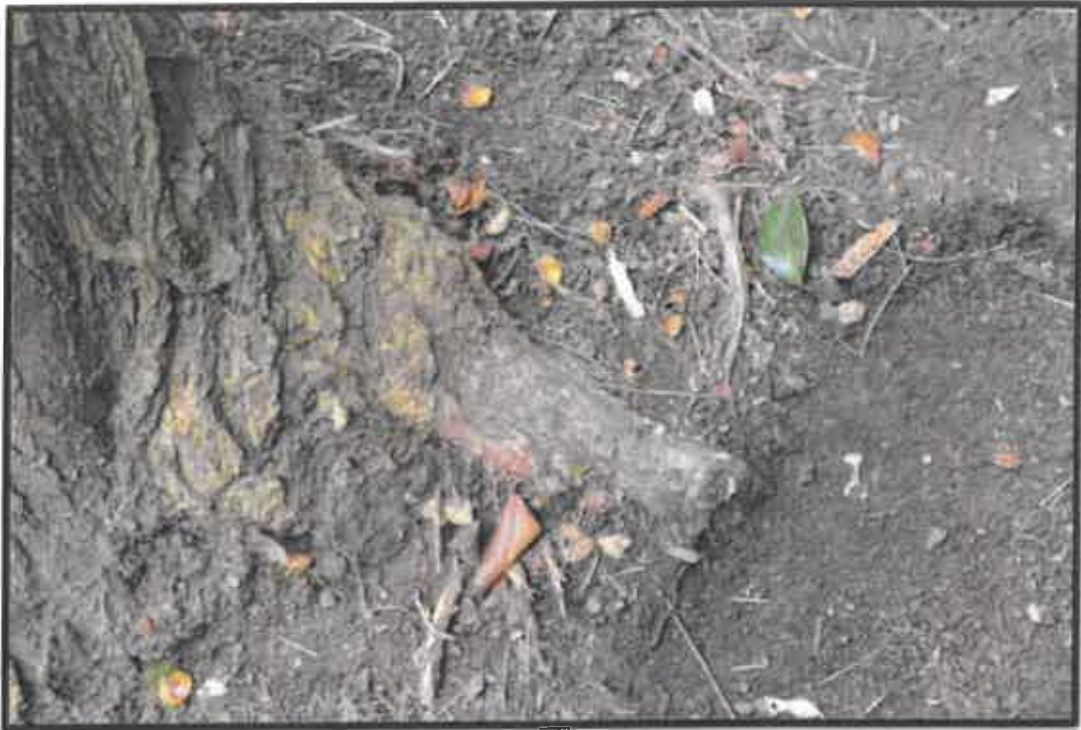
Picture showing the large irremediable decaying structural root, which will continue to develop for the remainder of the tree's life.

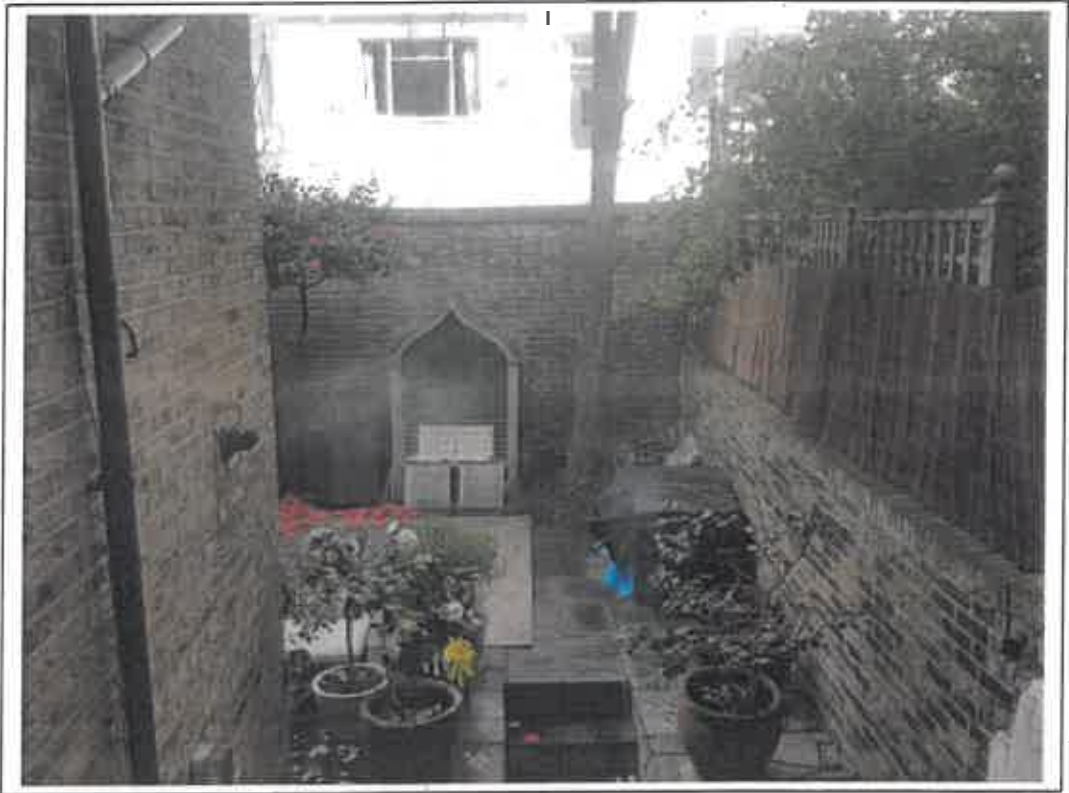
Measured from the rear garden of 21 Chepstow Place the wall is 3.0 metres high from garden level and appears to be constructed in 215mm thick solid bonded brickwork. See Photograph 1. The wall runs continuously past the rear of the properties in Chepstow Place in both directions and appears to have been originally constructed as an independent structure. The party fence walls both sides of the property are lower at approximately 1.5 metres above garden level and do not appear to be bonded into the rear wall. A mature tree, thought to be a false acacia, is growing very close to the inside face of the wall. It is apparently from the inside that the wall has an appreciable lean outward.

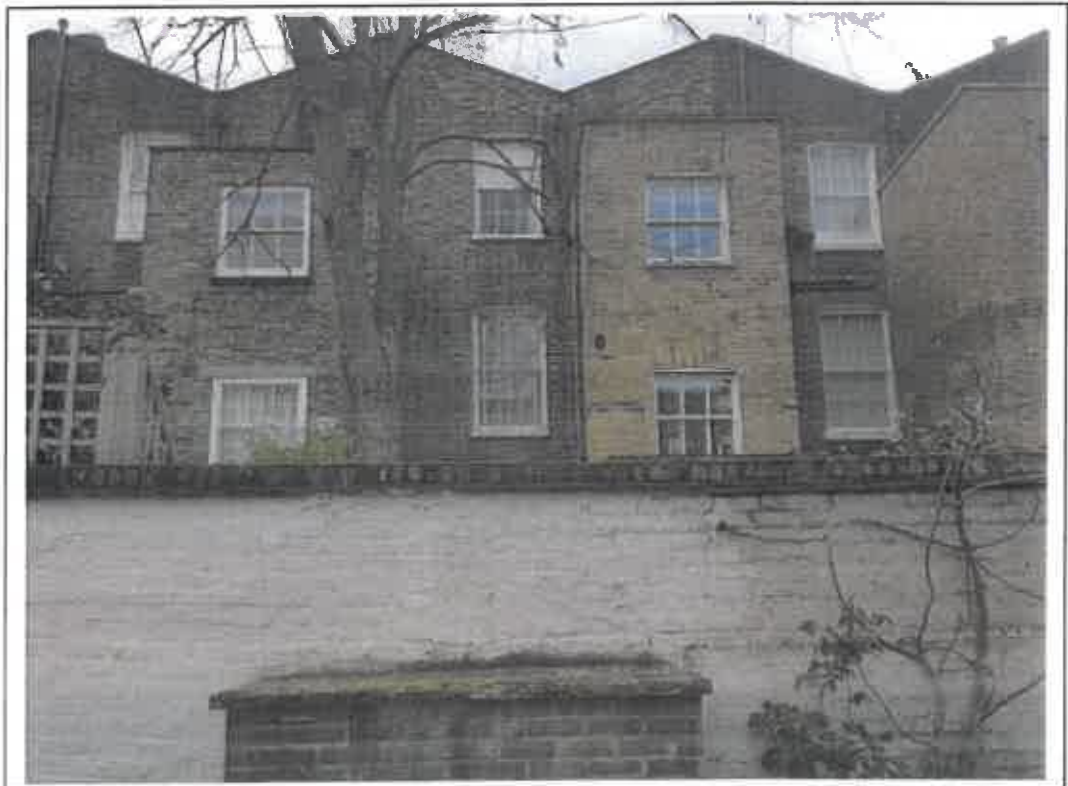
Photograph 2.

When viewed from the far side of the wall the outward lean can be measured and is at least 100mm. When measured from Rede Place the wall is only 2650mm high meaning that the ground on the Rede Place side is 350mm higher than the garden level. Despite this the wall still leans outwards. See Photographs 2, 3 and 4.

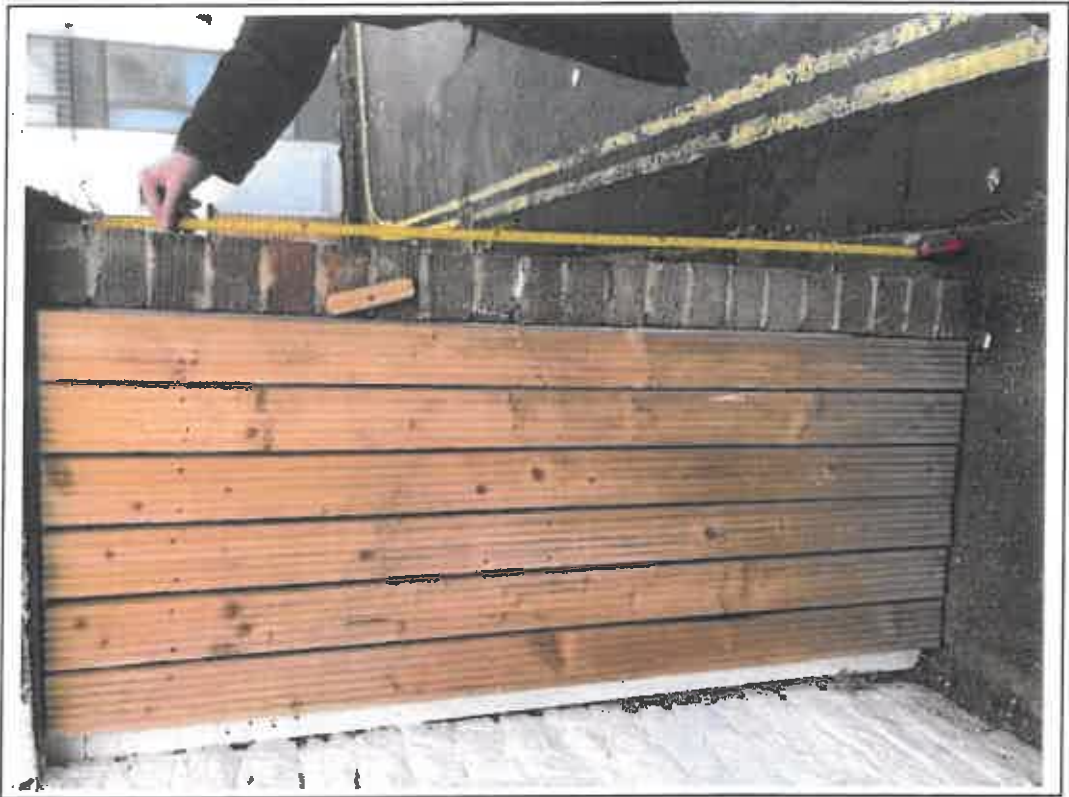
A bin store has been built up against the outer face of the wall but this has failed to buttress the wall in any way, as the bin store wall itself leans outward by 50mm and consequently it is clear that movement in the main wall has pushed over the bin store wall subsequent to its construction. See Photograph 5.

While it may be possible to stabilise the wall by introducing buttresses, this is unlikely to be an acceptable solution as it would involve construction beyond the curtilage of the property. We would consider that the only satisfactory means of the repair would be to take the wall down and reconstruct it plumb. As the primary cause of the problem is the growth of the adjacent tree, it is essential that the tree is removed as part of the operation and that the wall is rebuilt on a new foundation that extends below the level of tree root activity. We would also recommend that in rebuilding the wall it is tied into the returning party fence at each side to provide a buttressing action and add stability to the relatively high wall.

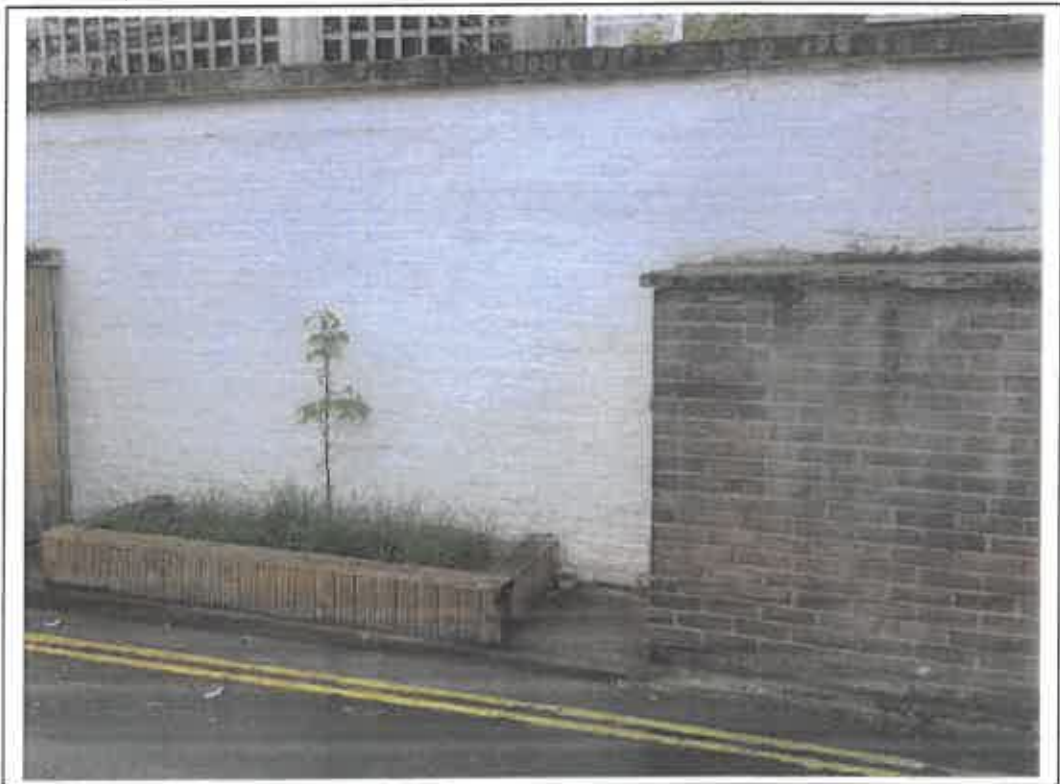
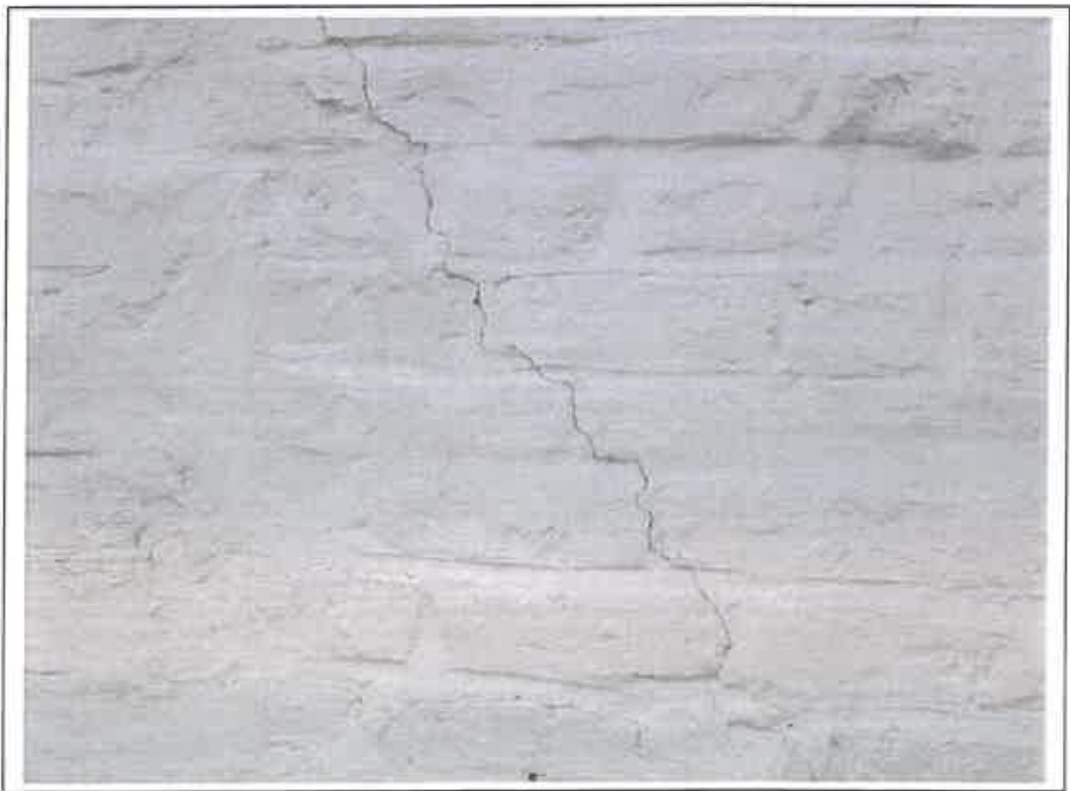
Photograph 6.

Significant distortions can be seen in the bed courses of the wall together with signs of previous repairs. However relatively fresh cracking is evident in the immediate vicinity of the tree. See Photographs 6, 7 and 8.

There is little doubt that the growth of the tree over the years has resulted in distortions in the wall as well as the outward lean. This is supported by the fact that the retaining element of the wall would normally result in the wall leaning inwards. It is also clear that the movement is active due to the relatively fresh cracking that can be seen in the previously repaired brickwork. The outward lean of the bin store gives a clear indication that much of the outward movement in the wall has occurred since the construction of the bin store.
