Arboricultural Appraisal Report

Subsidence Damage Investigation at:

**55 Hamilton Terrace
London
NW8 9RG**

**CCTV REPORT FOR: 55 HAMILTON TERRACE
LONDON
NW8 9RG**

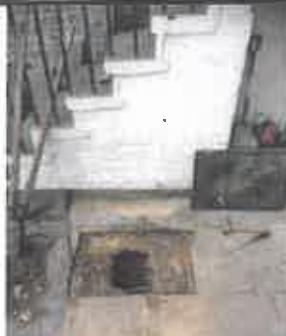
Location: Rear Garden		B/H No. 1	
Ground Surface: Dry	Weather: Dry	Date: 22-Nov-18	
		Roots Depth & Diameter: Down to 1.5m up to 2mm diameter	
		Water Depth Hit & Rise: None observed on site	
<u>Borehole Only</u>			
Depth (m)	Soil Descriptions (Field crew description only)	Test	
		Type	Depth (m) From To
G.L.			
1.05	Firm brown CLAY		
2.00	Stiff brown CLAY		
3.00	End of Borehole		
Photograph

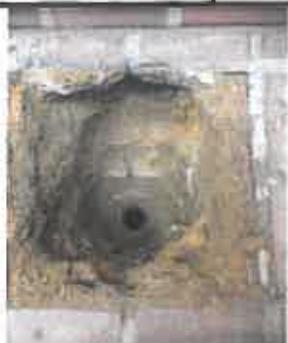
Depth (m)	Soil Descriptions (Field crew description only)	Test Type		Depth (m)	
		From	To		
G.L.					
0.59	Firm brown CLAY				
1.00	Stiff brown CLAY				
3.00	End of Borehole
